Product Advisory Notice	08/07/2010
	Document Reference: FXIR013

Product: Xgard IR hydrocarbon and CO₂ gas detector
Subject: Product advisory notice: IR sensor module failure

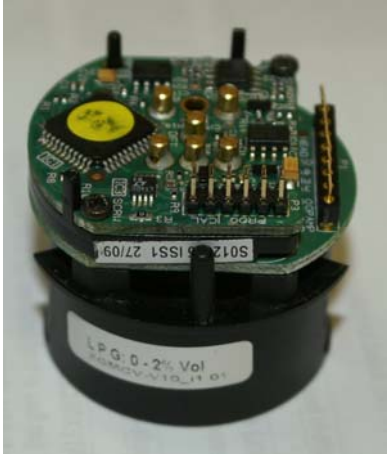
Xgard IR Sensor Module

A very small number of detectors have recently been reported for failing to respond to gas. The affected detectors produce a 4mA (healthy) signal but do not respond when test gas is applied. Users are also unable to set the sensor balance on the detector amplifier.

Investigations on returned units have revealed a component fault which affects sensor module PCB's manufactured in June/July 2009. All of the detectors had passed Crowcon's production tests prior to being despatched. In most cases the fault was observed when the detectors were commissioned on-site, however two detectors had been in operation for some time before the fault was revealed.

All detectors or spare sensor modules delivered between June 2009 and July 2010 should be gas tested immediately to ensure the sensor responds appropriately.

Failed sensors will be replaced under warranty, a replacement sensor module will be issued and a Customer Returns Number (CRN) will be notified. The faulty sensor must be returned to Crowcon for inspection immediately.

The replacement sensor module must be installed, commissioned and calibrated as instructed in the product Installation, Operating and Maintenance Instructions. The affected part is pictured below for reference.
