Product Advisory Notice	08/07/2010
	Document Reference: FXIR013

**Product: Xgard IR hydrocarbon and CO<sub>2</sub> gas detector**  
**Subject: Product advisory notice: IR sensor module failure**

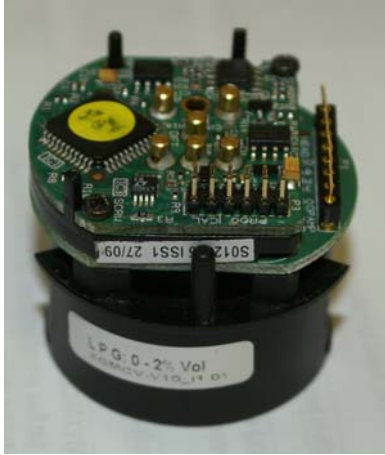
Xgard IR Sensor Module

A very small number of detectors have recently been reported for failing to respond to gas. The affected detectors produce a 4mA (healthy) signal but do not respond when test gas is applied. Users are also unable to set the sensor balance on the detector amplifier.

Investigations on returned units have revealed a component fault which affects sensor module PCB's manufactured in June/July 2009. All of the detectors had passed Crowcon's production tests prior to being despatched. In most cases the fault was observed when the detectors were commissioned on-site, however two detectors had been in operation for some time before the fault was revealed.

**All detectors or spare sensor modules delivered between June 2009 and July 2010 should be gas tested immediately to ensure the sensor responds appropriately.**

Failed sensors will be replaced under warranty, a replacement sensor module will be issued and a Customer Returns Number (CRN) will be notified. The faulty sensor must be returned to Crowcon for inspection immediately.

The replacement sensor module must be installed, commissioned and calibrated as instructed in the product Installation, Operating and Maintenance Instructions. The affected part is pictured below for reference.
