Crowcon Technical Note

Document Reference: GEN061 - Control System Software

Subject: System operation in sensor over-range state

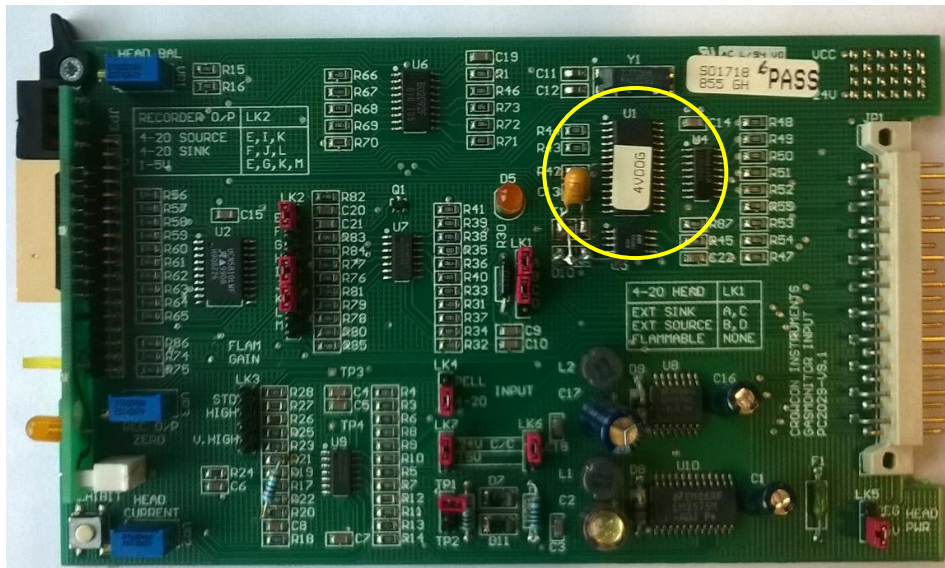
Input Module Software revisions affected	3V00G, 4V00G
--	--------------

The Gasmonitor software revision is identified by a label on the input module (see below).

If software upgrade is required, the input module must be replaced. If modules are replaced, the module and system configuration must be re-checked and the module must be re-calibrated along with the connected detector.
